## **Composite Failure Analysis Handbook Update #1**

*Greg Walker*

*Boeing Defense & Space Group*

**April 1995**

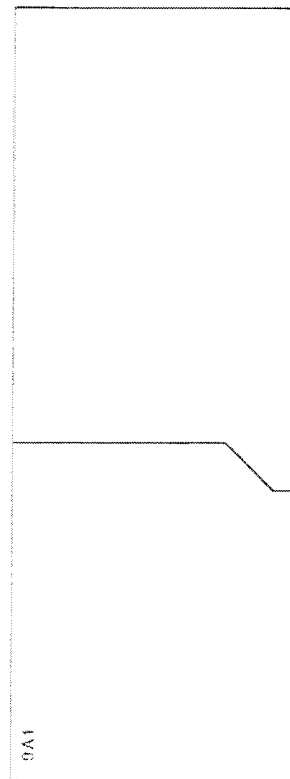
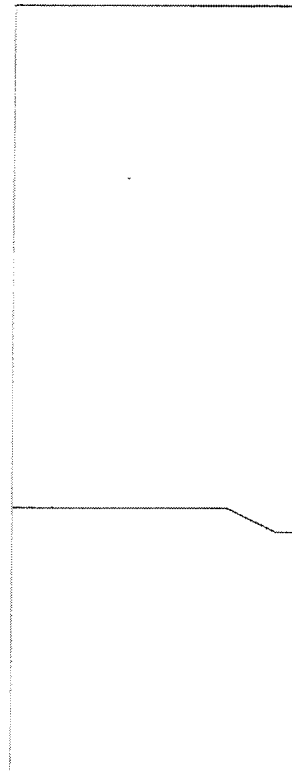
Figure 3.8-28. Undercured Face Sheet Sample 9A1—2.4X Reduction

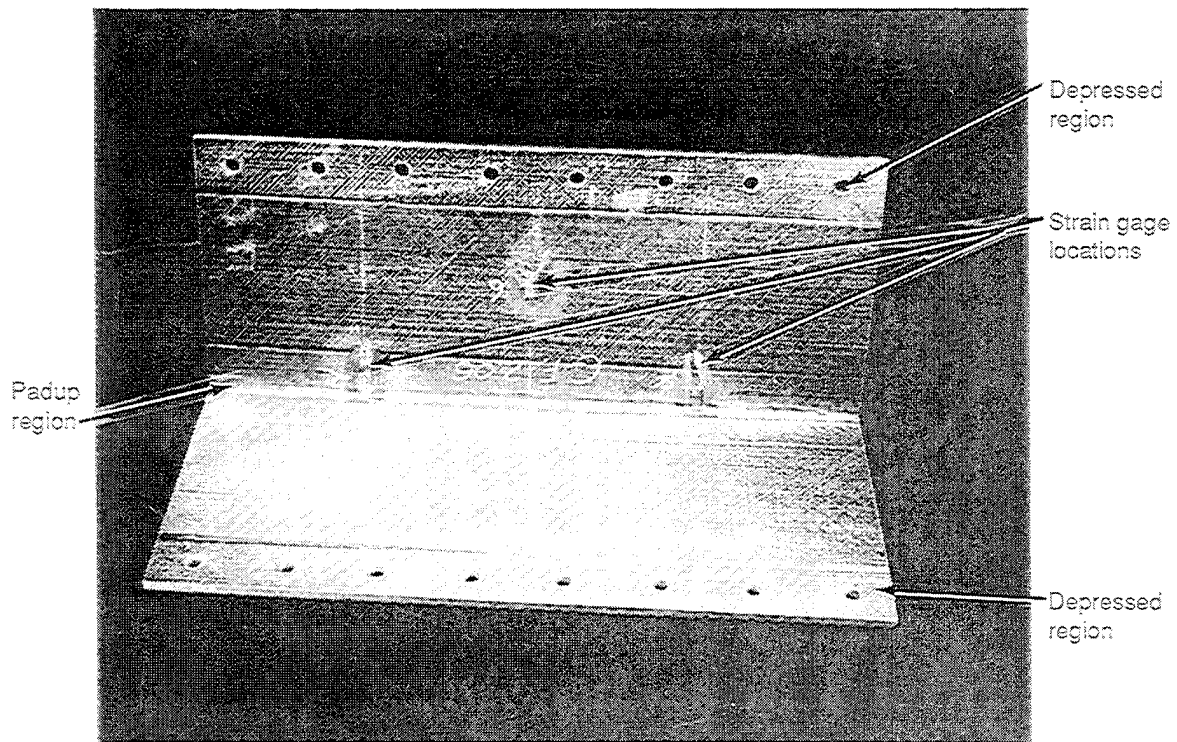
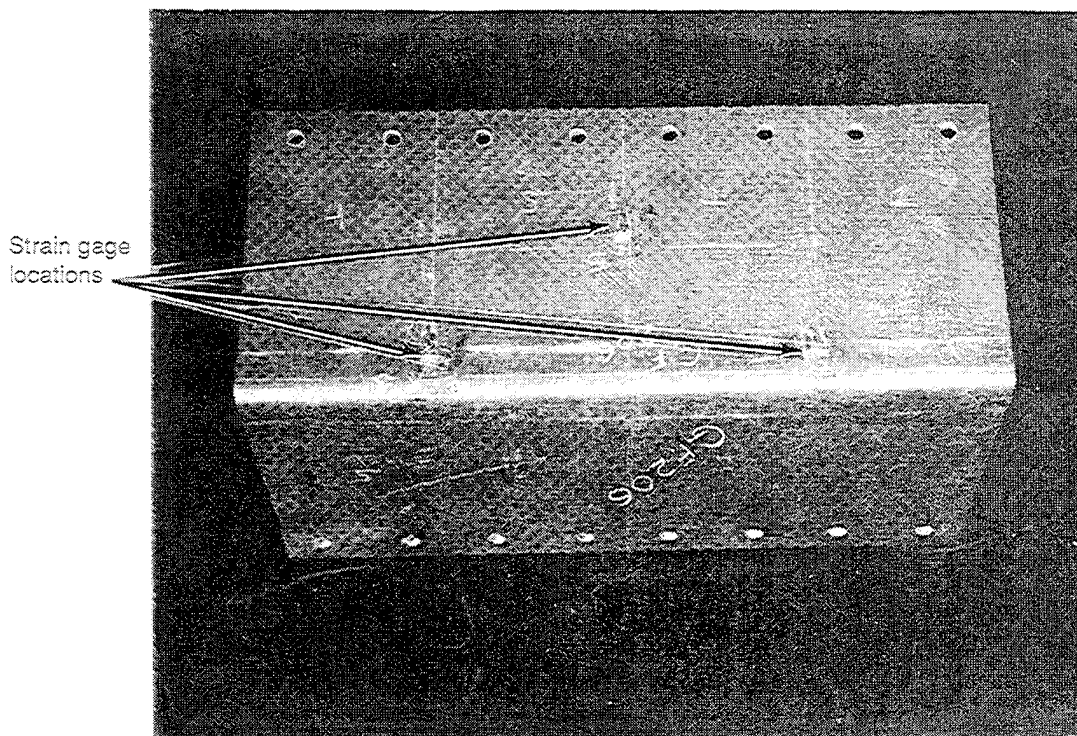
Figure 2. Photographs of the As-Received Component

The submitted component (shown in fig. 2) was approximately 14 inches long with 5-inch wide flanges. The thickness was approximately 0.17 to 0.20 inch. The angle between the two flanges was approximately 95 to 100 degrees. The overall color and appearance was indicative of a carbon fiber-reinforced plastic system.

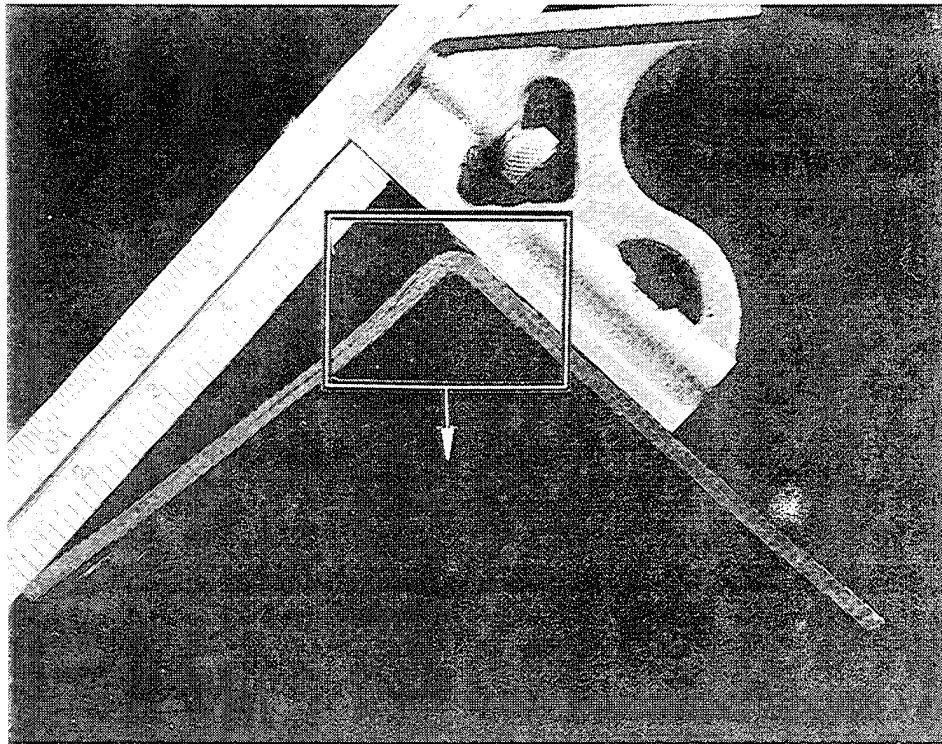
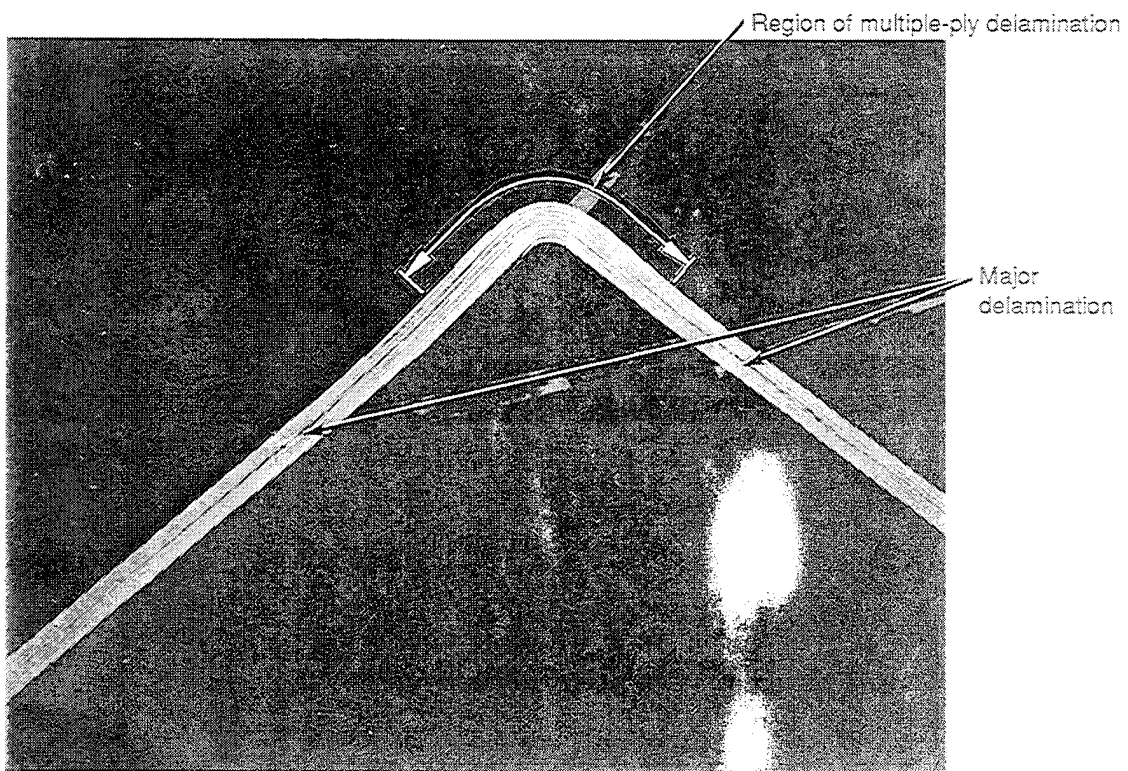
Internal delaminations, observe from both ends of the part, extended from the "knee" or angle region to the edges of the flanges (fig. 3). A 3-inch long delamination was located along the center plies. This delamination extended from an inserted ply placed within the center of the fiber plies at the knee region.

Figure 3. Photographs of the Edge of the Component Showing the Extent of Delamination

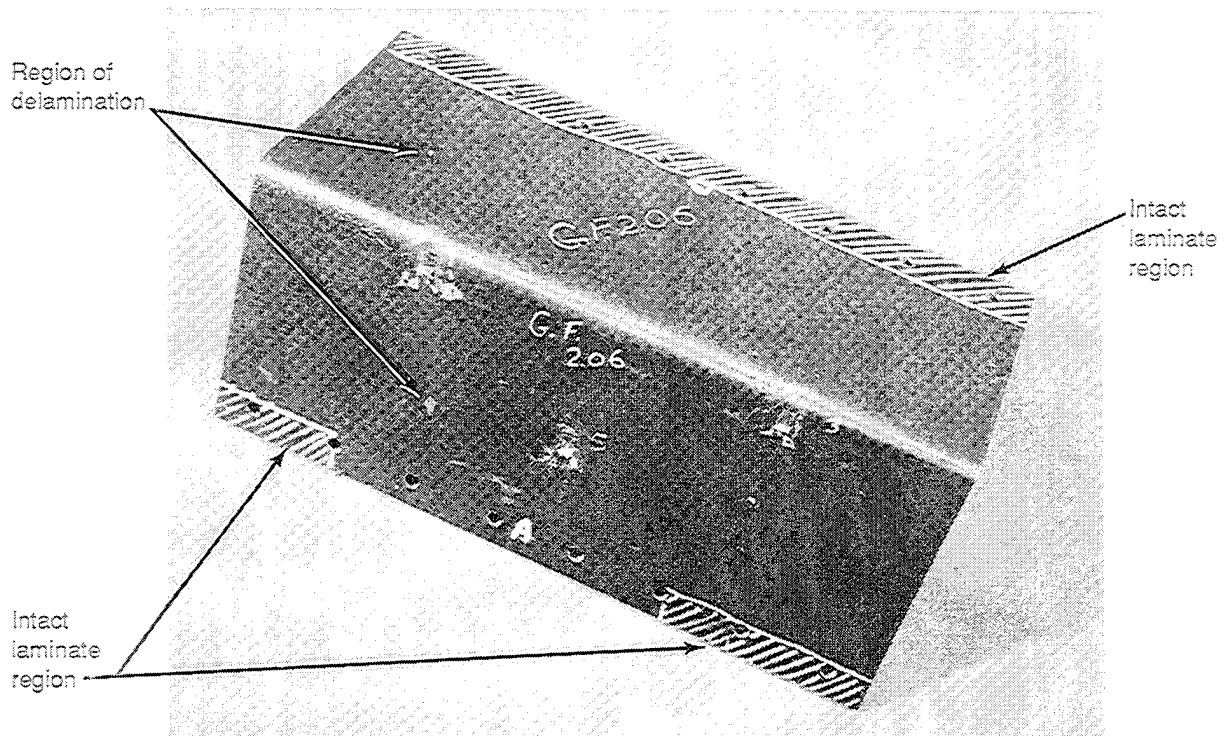
Examination using a handheld pulse-echo unit (C-scan) with a .25-inch transducer identified delaminations throughout the component (see fig. 7) except at certain locations along the region containing the fastener holes.

Figure 7. Photograph Showing the Regions of Intact Laminates Identified Using Pulse Echo

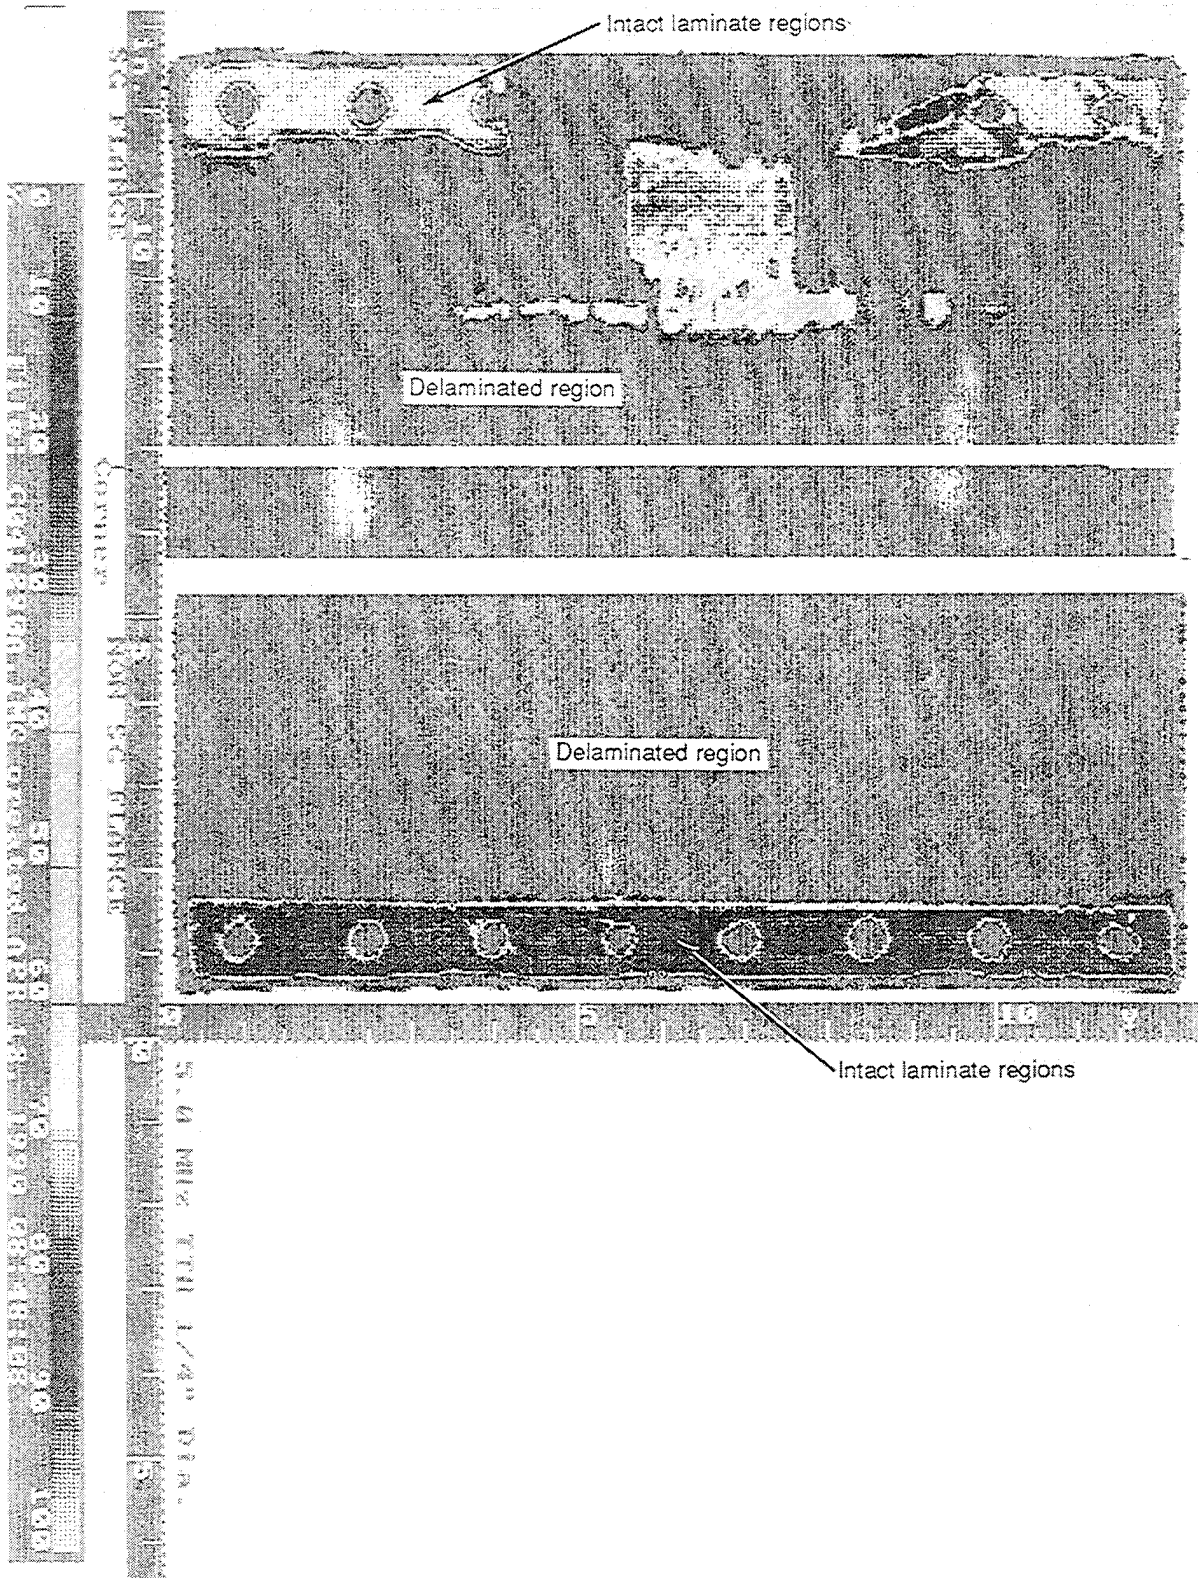
The part was subsequently dried in an oven at 90°F for 30 minutes before another set of scans was performed. This time the edges were sealed, the surface of the part was sprayed with a lacquer, and the fastener holes were plugged (fig 9). The part was then rescanned which revealed that it was almost completely delaminated (fig. 10). The grip areas were not delaminated as observed in the pulse-echo analysis.

Figure 10. TTU Scan, After Drying and Sealing the Component, Exhibiting Delamination Regions Similar to the Pulse-Echo Examination

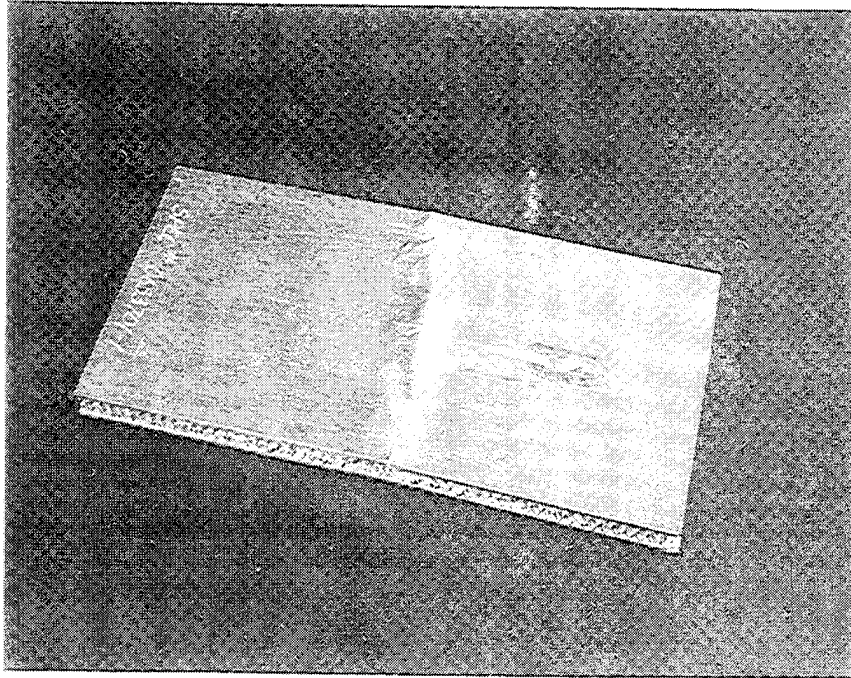
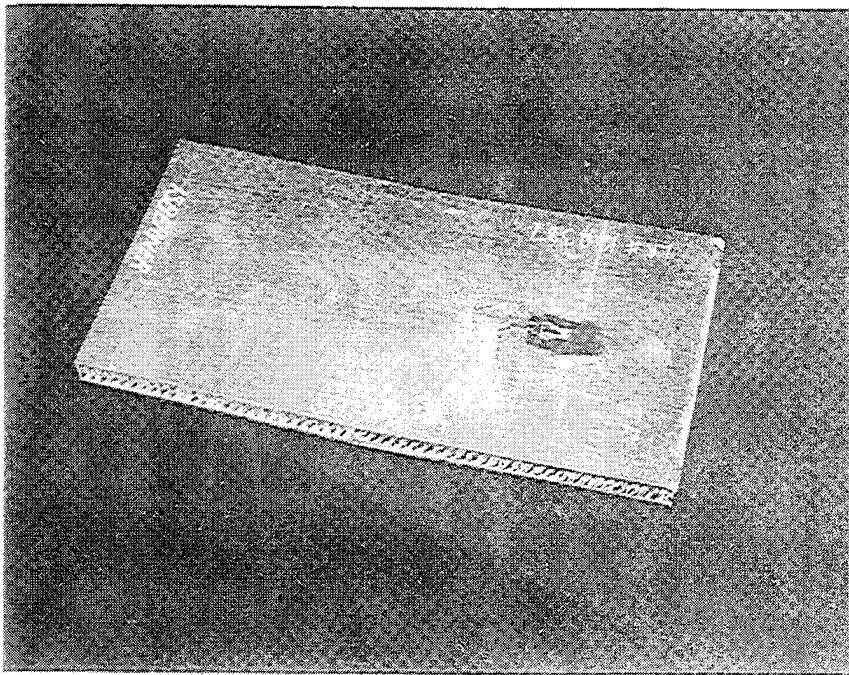
Figure 2. Photographs Showing the Top and Bottom Surfaces of the As-Received Component

The component was a rectangle metal honeycomb sandwich panel with carbon fiber composite face sheets. It was approximately 0.6 inch thick, measuring 9.0 inches by 6.0 inches (see Figures 2 & 3). The top surface contained a transverse bulge located in the middle of the panel approximately 1 inch wide. The bottom surface was generally warped. Examination of the honeycomb core along the edges revealed that all of the honeycomb core was damaged (see Figure 3). However, no honeycomb/adhesive failures were observed, only the cell walls were deformed with the bonds to the facesheets being intact.

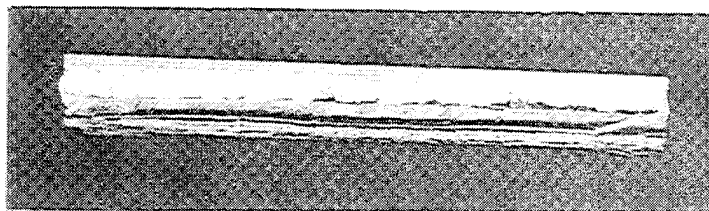
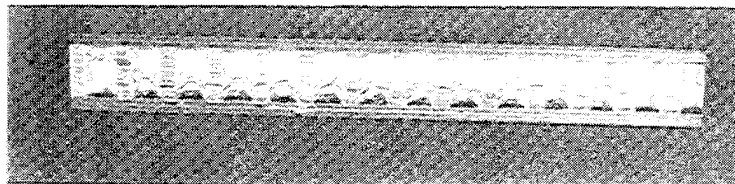
*Figure 3. Photographs Showing the Front, Back and Sides of the Component*

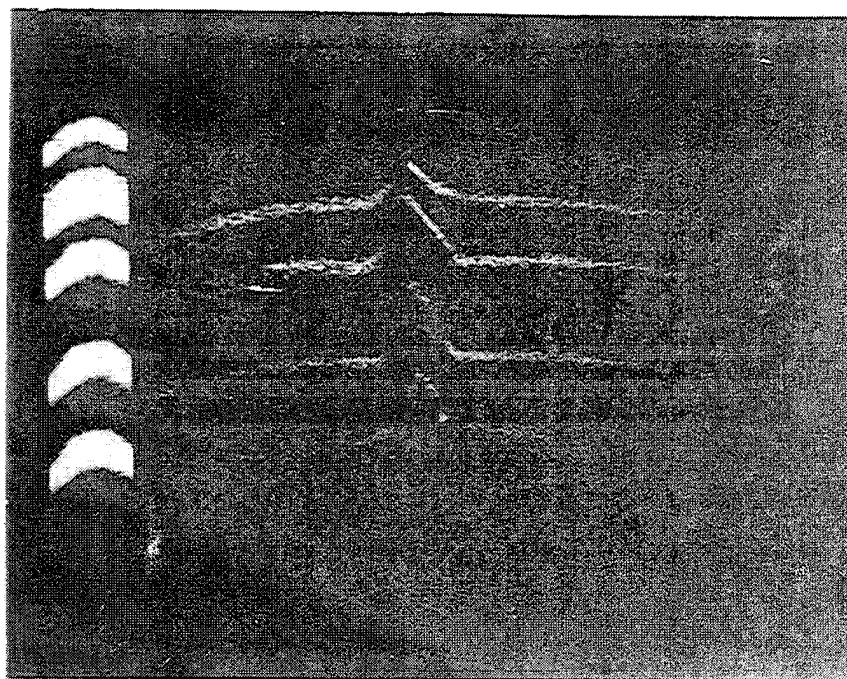
*Figure 4. Buckled Surface Showing the Angled Slit Lighting Contours*

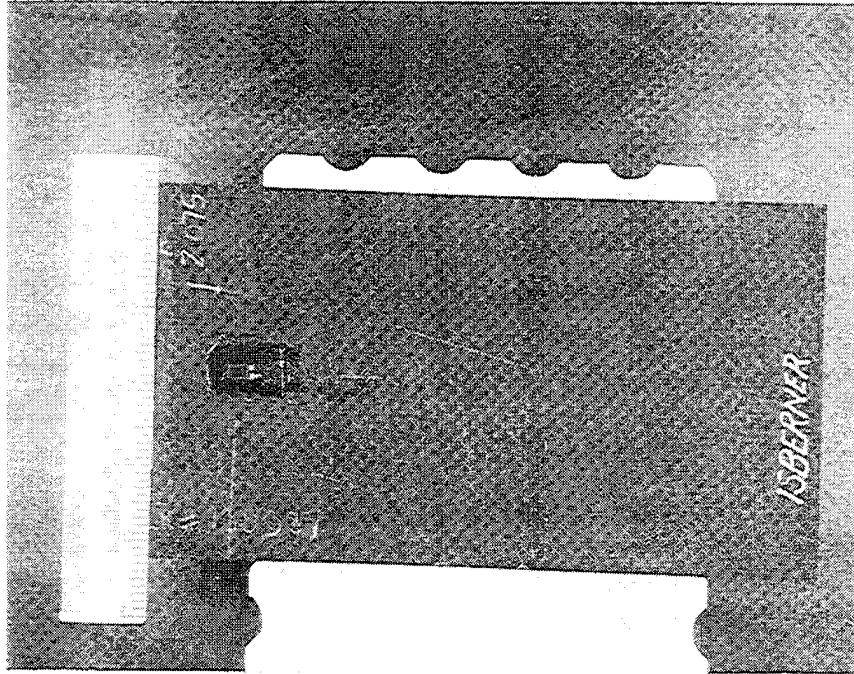
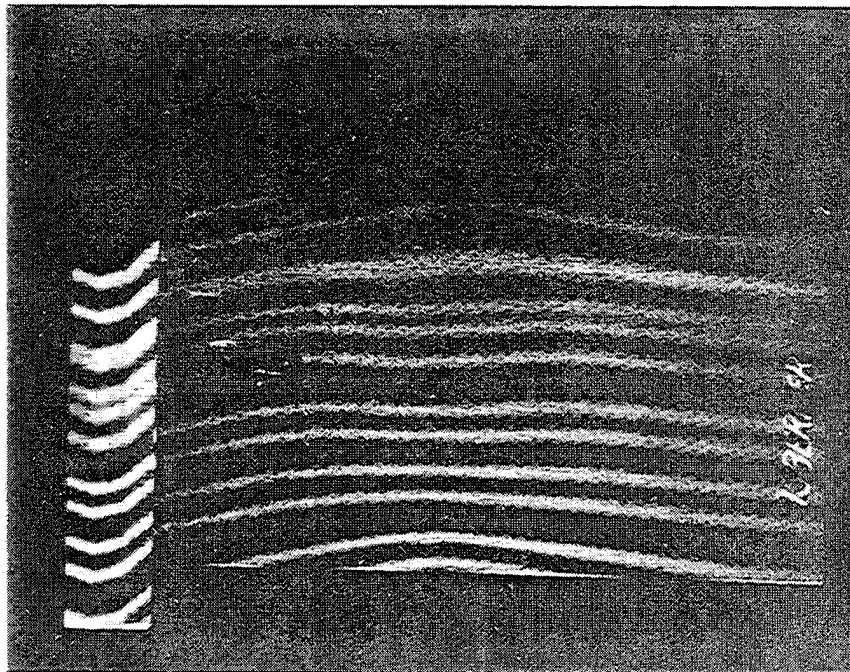
Figure 5. Smooth Surface Showing the Angled Slit Lighting Contours

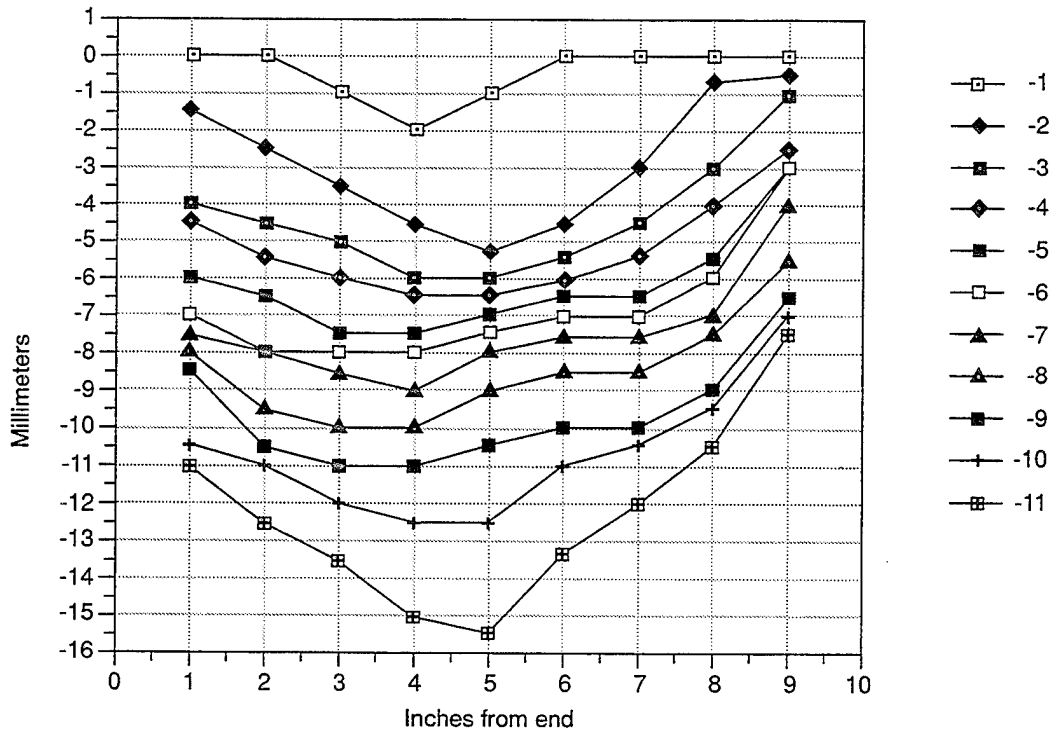
Horizontal displacement of lines 1 through 11 in millimeters at intervals of one inch along the length of the panel

Figure 6. The Vertical Displacement is Equal to 0.39X of the Horizontal Displacement of the Slit Image. Horizontal Displacement of the Slit Image as a Function of Length.

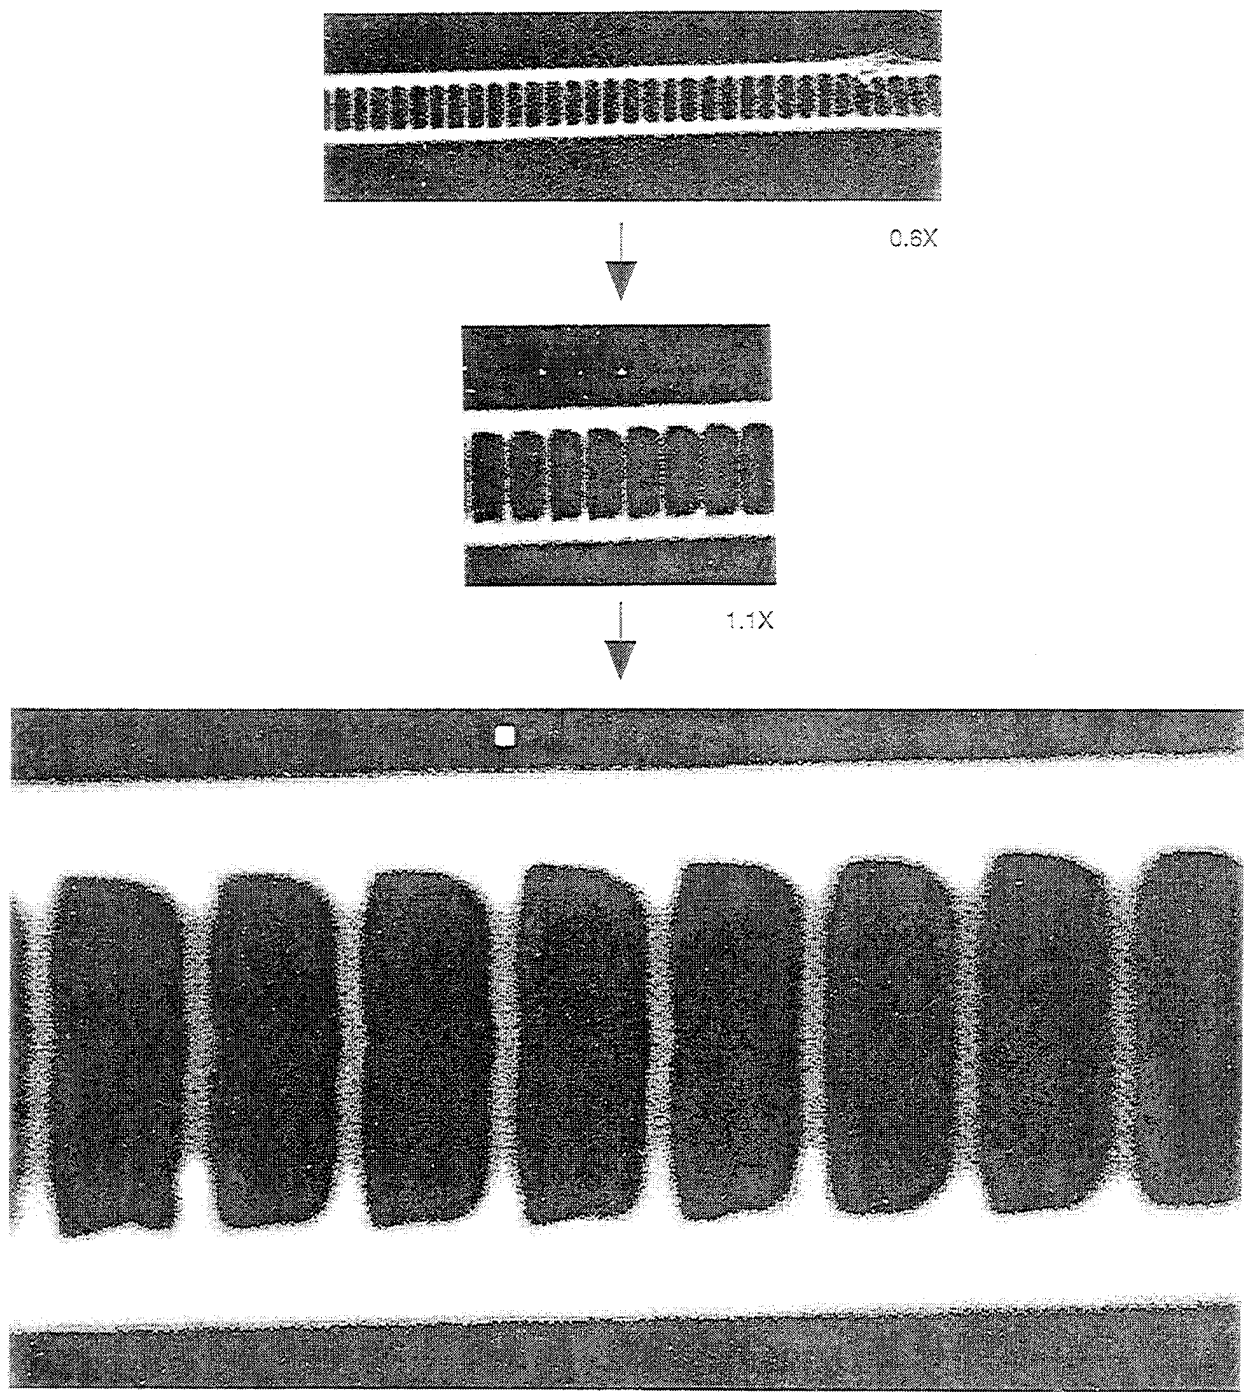
Figure 9. CT Images of the First Longitudinal Scan

Figures 8 through 11 show the various images of the slices through the component. The longitudinal slices 1, 2, & 3 show the damage present in the honeycomb regions in the center of the component. The front half of the panel appears to have been crushed by a macroscopic shearing of the upper front half of the facesheet. The back half exhibited little if no damage. However near the bulge, the core appeared to be crushed in the short transverse direction. There was no evidence showing any longitudinal buckling trends to either end (from one end to the other). This transverse damage was located all along the back half of the component.

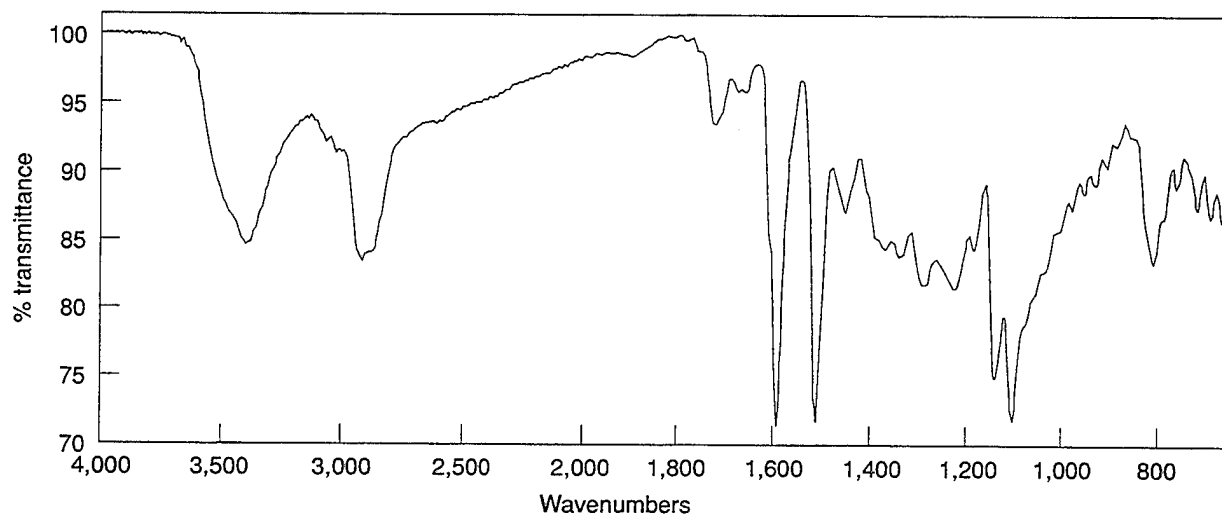
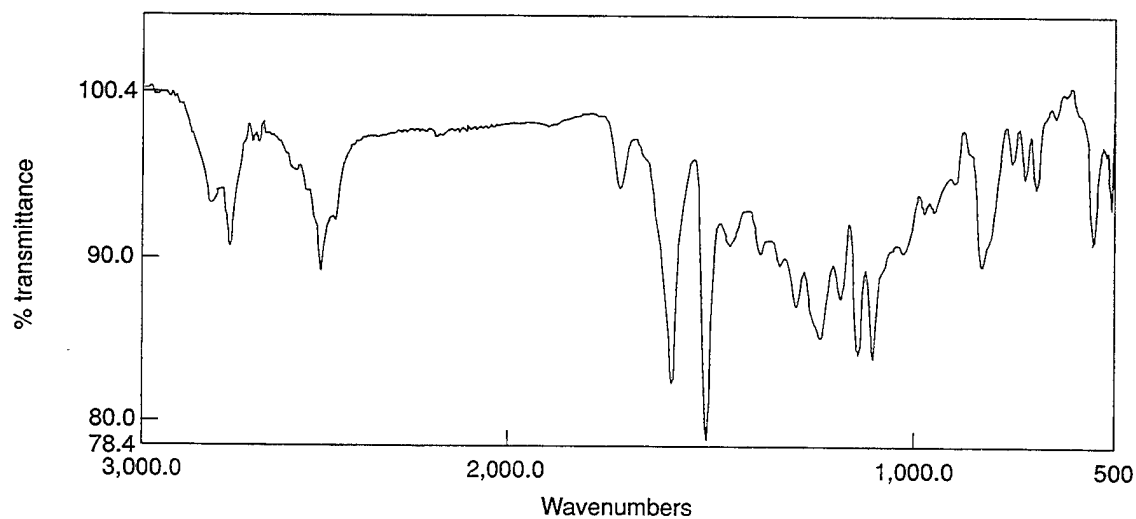
Figure 12. FTIR Plots of the, (a) Resin From the Honeycomb Panel, and (b) From a Data File of Hercules 3501-6

The facesheets were composed of carbon fibers in a 350° F cure epoxy resin system similar to the Hercules 3501-6 resin (see Figure 12 ). DSC analysis of the resin system revealed that the resin was fully cured (as shown in Figure 13a).

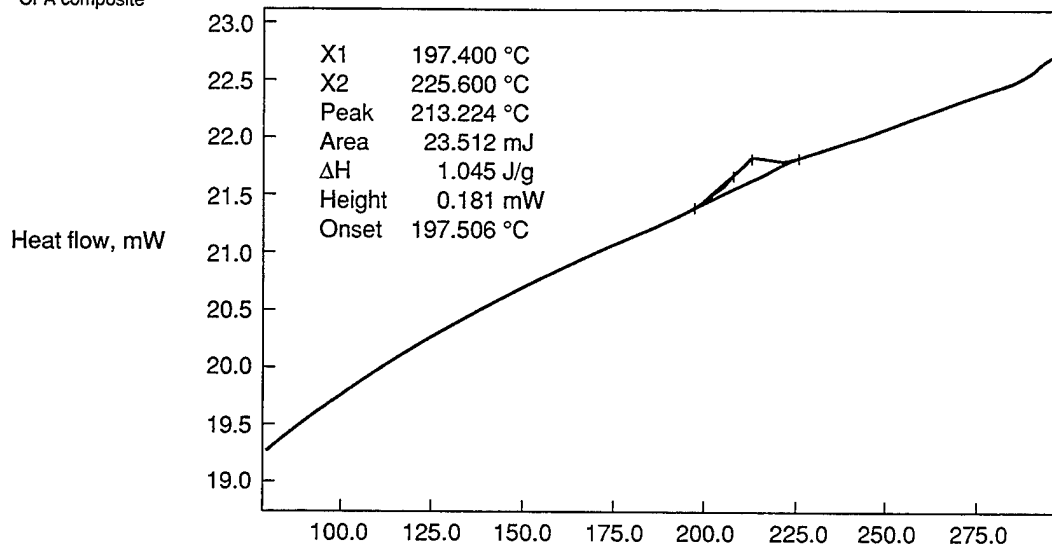
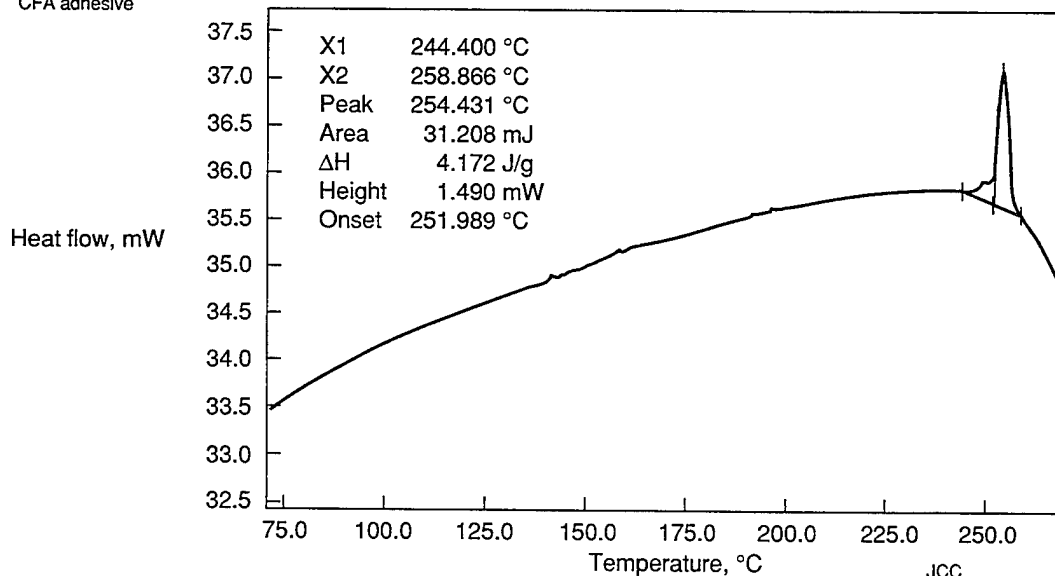
Figure 13. DSC Plots of the (a) Composite and (b) the Adhesive

The adhesive was identified as an epoxy with additional compounds (Figure 13b). DSC plots revealed an endotherm peak which was determined to be the result of melting. Further analysis indicated that the adhesive was fully cured.

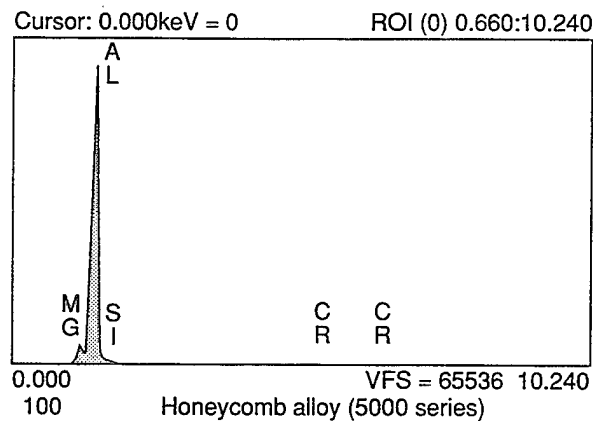
Figure 14. EDS Spectrum Showing the Major Elements That Have Been Detected and a Semi-quantitative Analysis of the Material

The honeycomb core was composed of a 5000 series aluminum as determined by the EDS analysis (Figure 14). Although aluminum honeycomb cores are usually made from 5000 type alloys, the EDS instrument is not accurate enough to identify the specific alloy in this series.

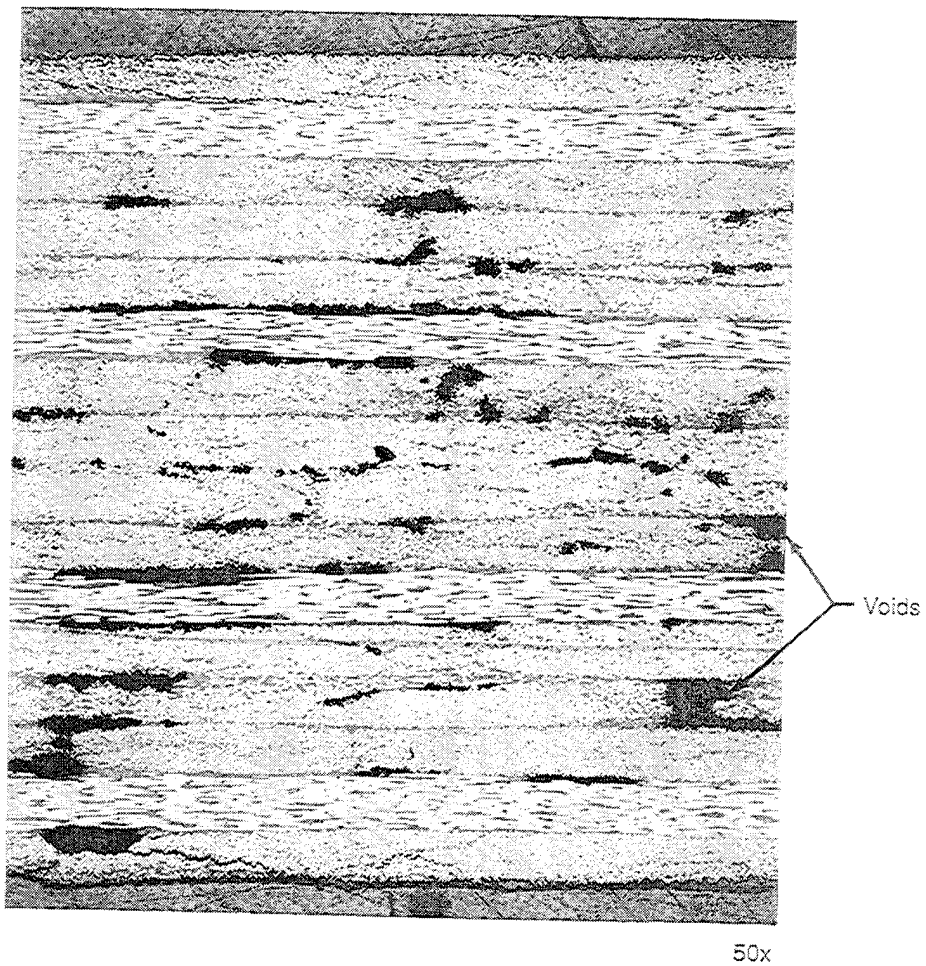
A small section of the panel was cut, mounted, ground and polished. The facesheet ply orientation sequence was: [(+45/90/0/-45)2]s. Major voids were observed throughout the facesheet (see Figure 15). This could be the result of incorrect processing of the composite material prior to assembly of the entire component because the adhesive bond appeared to have been processed correctly.

Figure 15. Cross-Sectional Micrograph of the CFRP Face Sheets  
Showing the Extent of Porosity and the Lay-Up Sequence

- d. There was a uniform distribution of voids or porosity throughout the CFRP face sheets.
- e. Damage to the honeycomb core was either deformation or fracturing. In both cases, the damage only occurred in the center of the cell walls and not at the core-adhesive region.

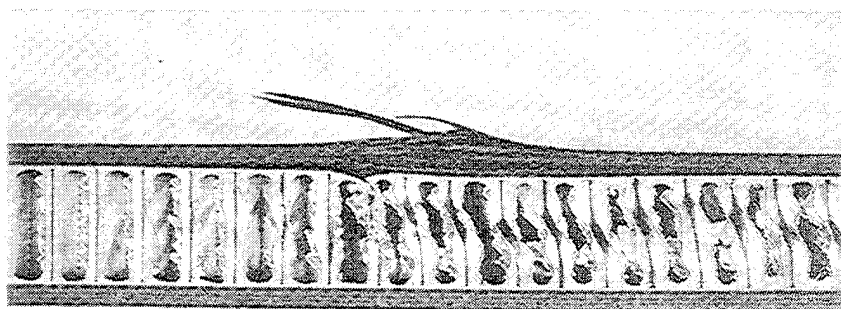
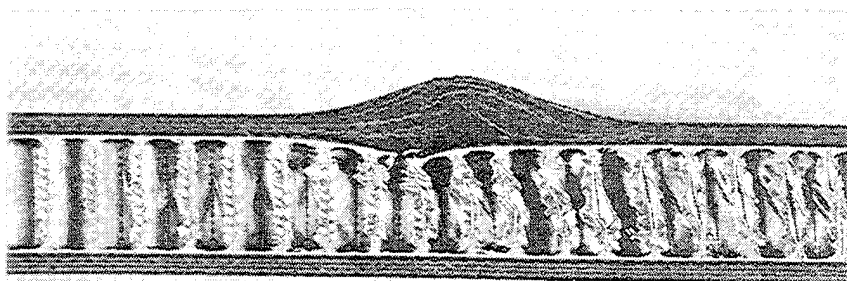
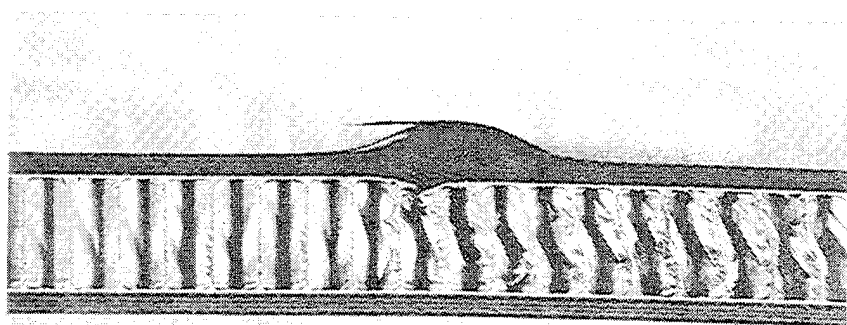
Figure 16. Photographs of Cross Sections Through the Panel Corresponding to the CT Scans:

The component was sectioned longitudinally along the same three locations as the CT scan slices to obtain a more detailed examination of the damage within the panel. Figure 16 shows the cross-section at the right edges of each section which correspond to the CT images in Figures 9 to 11. Examination of the surfaces reveal damage similar to the CT images.

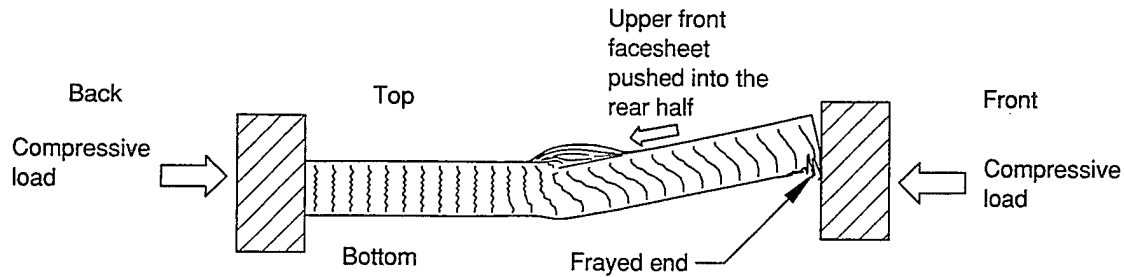
The transverse delamination region of the facesheets is indicative of compressive loading. There are two general ways in which the panel could have been loaded in order to cause a compressive loaded; the first would be a three point loading configuration; the other would be a simple longitudinal compressive loading applied to the ends of the panel. If the component had been loaded in the three point loading configuration, the bottom side should exhibit tensile cracking and the honeycomb core on either side of the transverse delaminated region would not have been damaged or deformed. However, examination of the internal structure by both the CT scans and the sectioning revealed a non-uniform deformation. The longitudinal compressive loading configuration would most likely have produced this type of damage. Figure 17 shows a diagram of the panel illustrating a plausible loading sequence that could account for the damage to the panel. As the load was applied to both ends of the panel, the top facesheet began to delaminate and eventually buckle. Then the front half of the top facesheet shifted towards the back, deforming the honeycomb core in the process. This in turn caused the panel to bend with the back half of the panel remaining relatively straight while the front half twisted downward which resulted in the edge of the bottom facesheet being frayed. The downward twisting movement also deformed the bottom of the panel.

Figure 17. Diagram Showing the Probable Loading Configuration and Subsequent Deformation of the Panel

- f. Based on the information collected from the examination, the damage most likely occurred as a result of longitudinal compressive loading.
- g. Other than the porosity, no other anomalies were identified that could have caused premature failure or crack initiation.

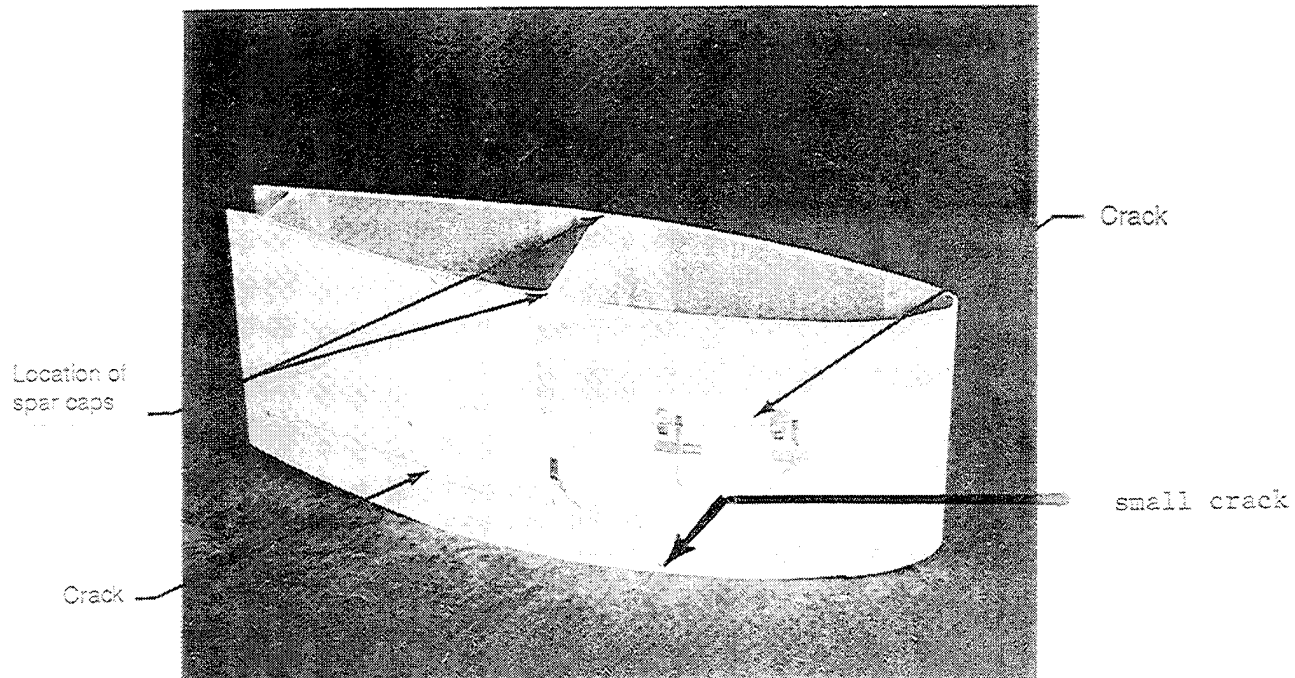
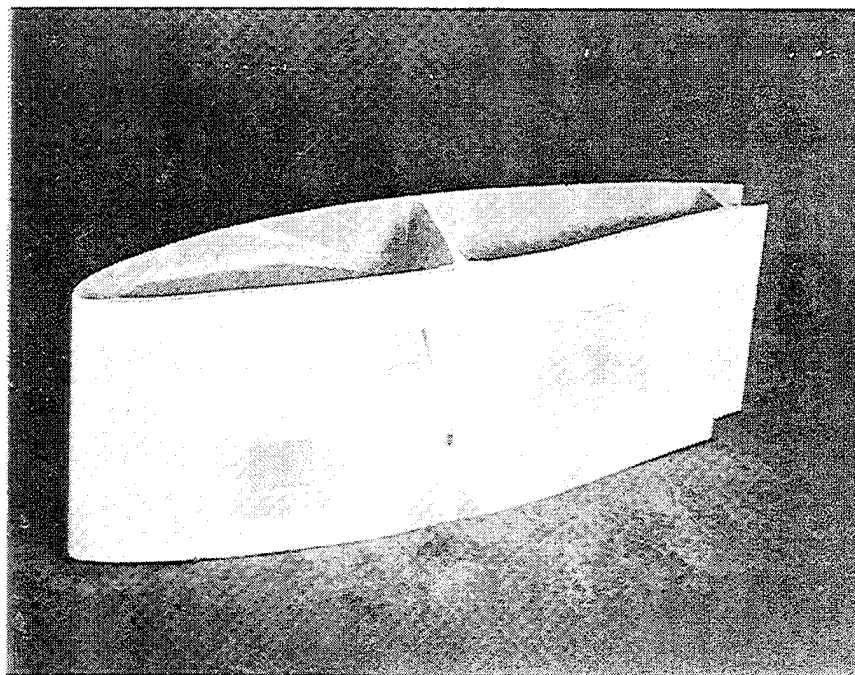
Figure 2. Photographs of the Outer Surfaces of the Wing Section  
 a) Upper Surface  
 b) Lower Surface

**Outer Wing Surface** - The upper wing skin was composed of a paper honeycomb core with layers of fiberglass plies on both sides. White Gelcoat was present on the outer surfaces. The upper skin contained two long cracks and one small crack. One long crack extended approximately three quarters of the way from the leading edge towards the aft. The other long crack was located between the mid spar and the aft spar. The small crack was located on the edge of the wing section near the middle of the wing section. In addition to the cracks; a large section of the surface, located adjacent to one edge and between the leading edge and the mid spar, had been sanded through the gelcoat.

The lower skin, fabricated identically to the upper skin, contained five regions which appeared to be in various stages of repair. Two of the regions (one ~5.5 and the other ~3.0 inch square) were located in the main section of the lower skin. Both contained exposed honeycomb and white potting compound along the perimeter of the exposed regions. In addition, the surfaces adjacent to these two regions were sanded. Another region (~2.0 inch square) simply had the honeycomb removed down to the inner surface skin. Finally, two sanded regions were located on the edge of the lower skin, one at the spar cap and the other aft of the mid-spar. Both of these regions were approximately 2 inch square and had also been sanded through the Gelcoat.

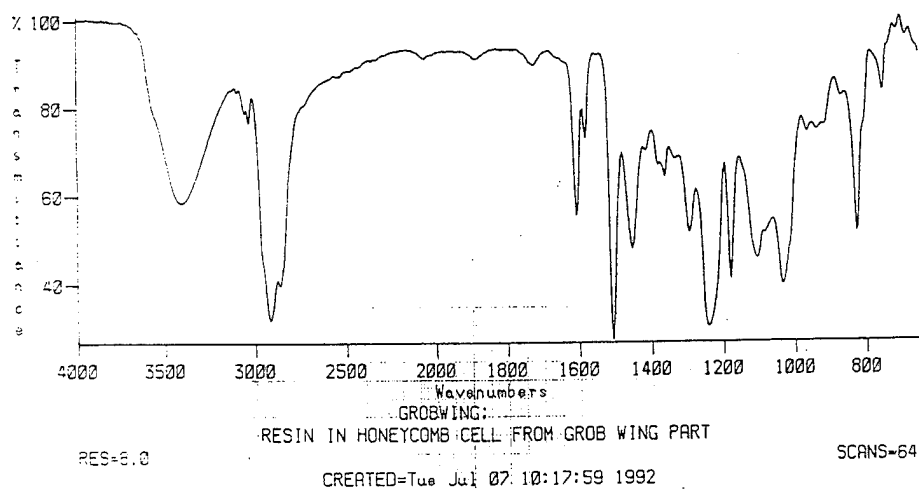
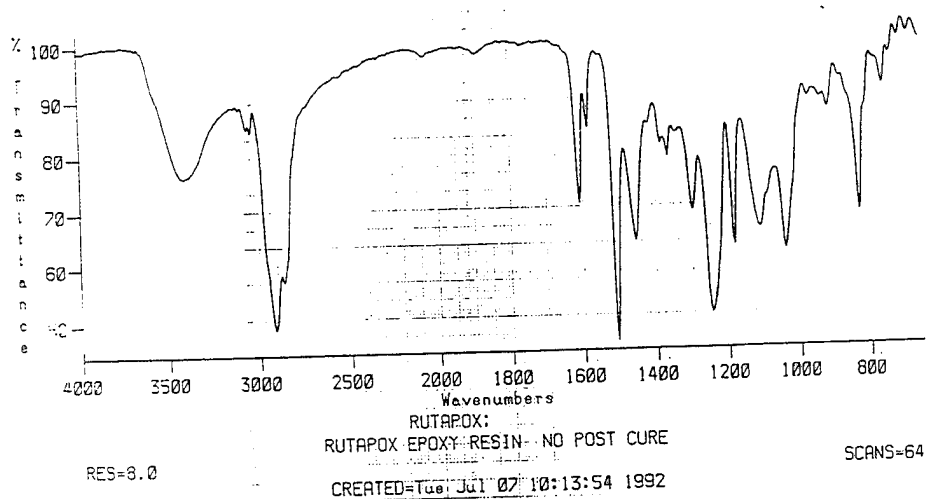
Figure 5. FTIR Plots of the Wing Section Specimen and the Rutapox  
a) Wing Section Sample  
b) Non-Post-Cured Rutapox Resin Sample

A Fourier Transformation Infrared (FTIR) analysis, used for determining the formulation of polymers, was performed on a sample of the resin used in the skins and compared to a sample of a partially cured Rutapox resin. The analysis indicated that both samples were essentially identical, confirming that wing section was fabricated using the Rutapox resin system (Figure 5).
